# Geology

Mountain Fire BAER  
(San Bernardino NF)

August 1, 2013

Jerome V. DeGraff, Sierra NF

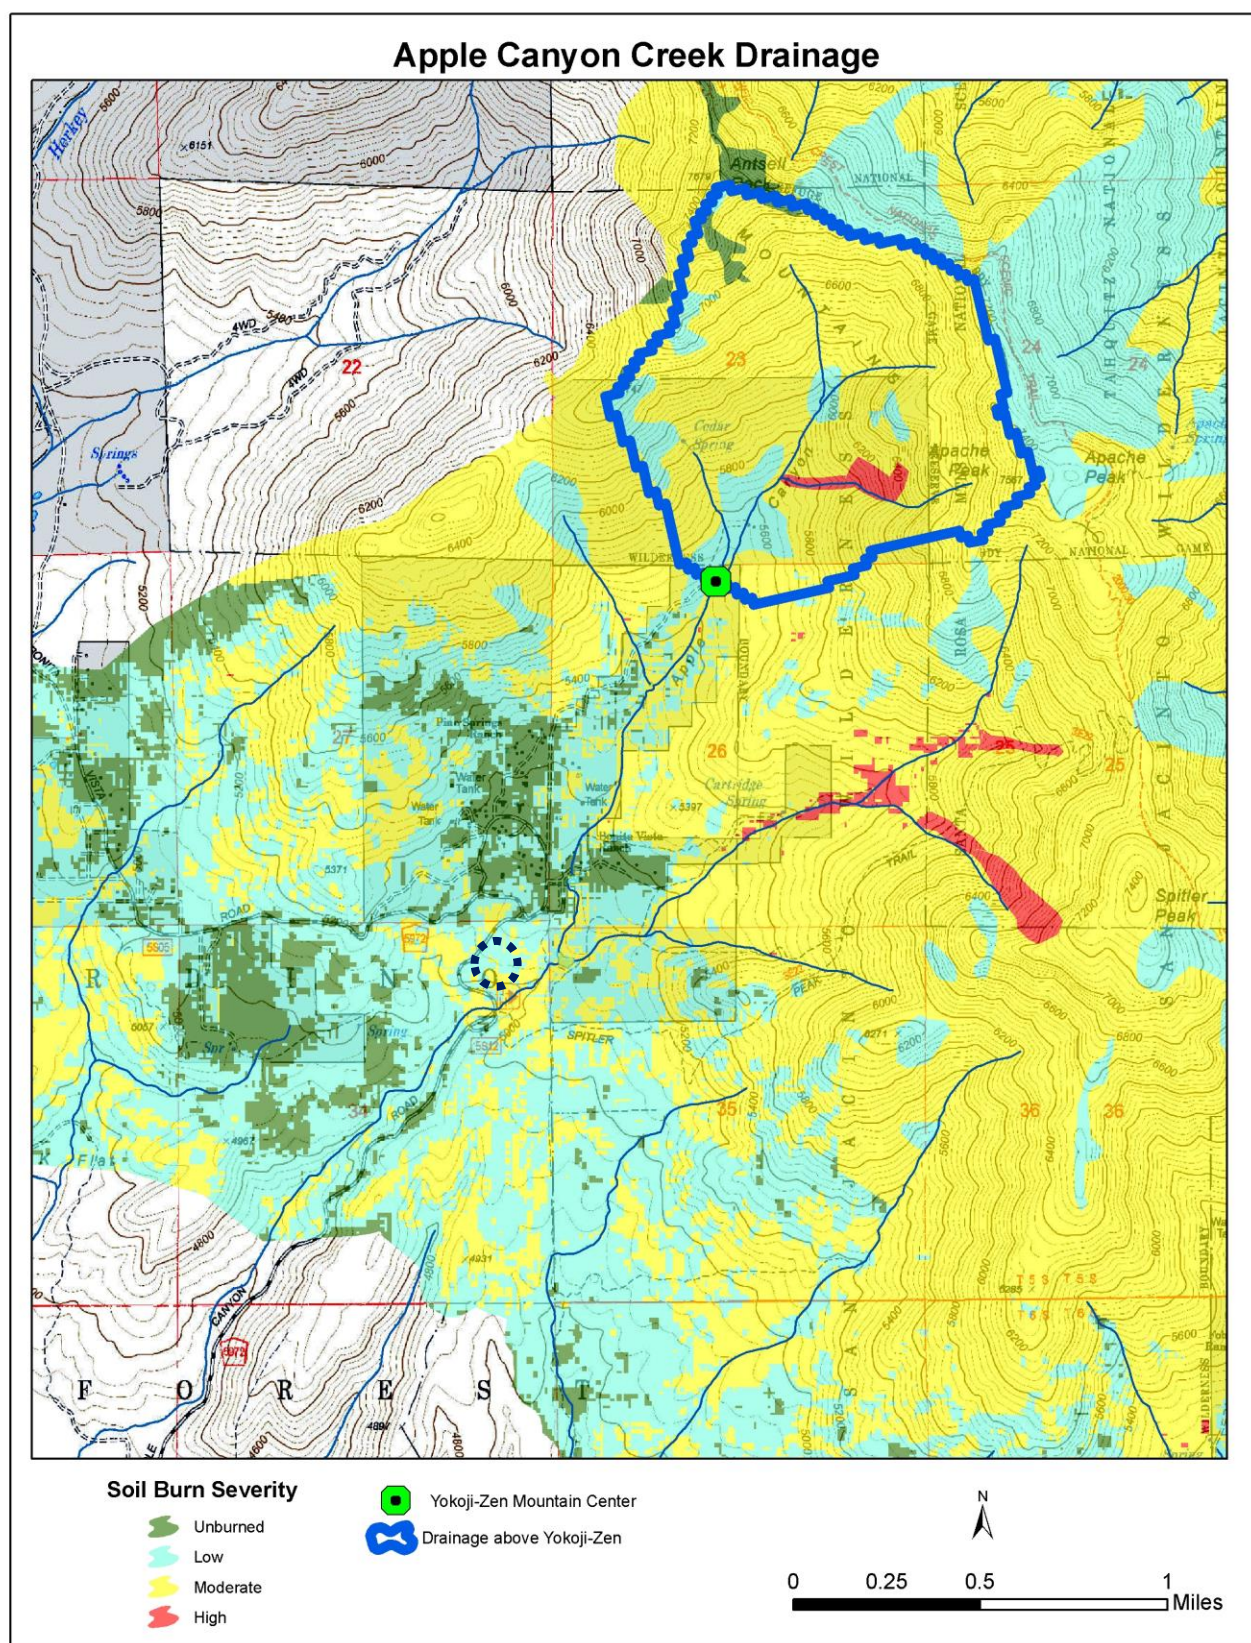
Figure 1. Map showing the soil burn severity within the upper Apple Creek drainage due to the Mountain fire. The 537-acre watershed which impacts the Yokoji-Zen Mountain Center is outlined in blue. The black dashed circle shows a pond which is not filled with sediment washed down from the severely burned areas upstream during the July 21<sup>st</sup> storm. Field evidence suggests this was a hyperconcentrated flood flow rather than a debris flow.

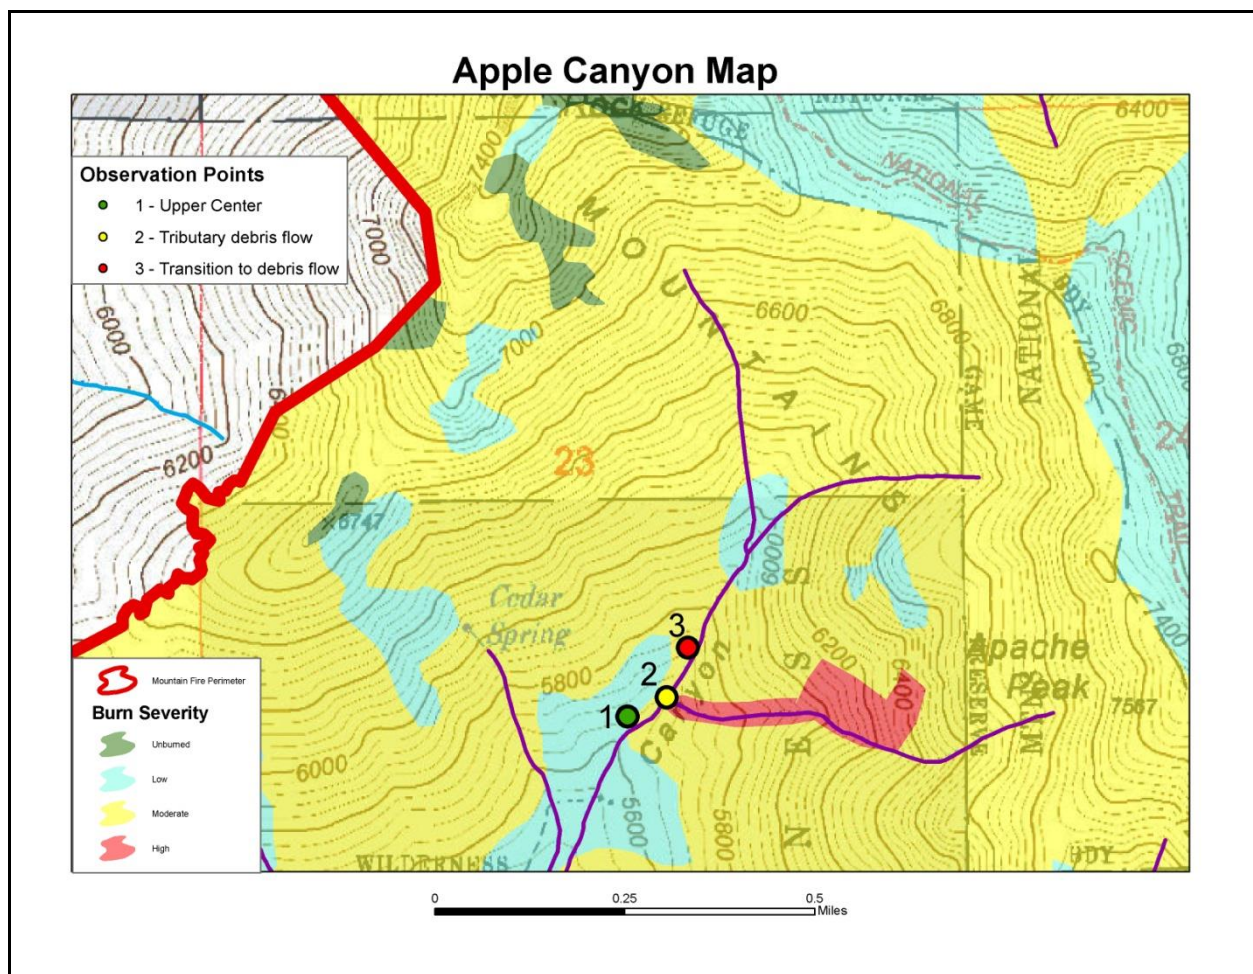
Figure 1. Map of the watershed which was the source of the debris flow impacting the Yokoji-Zen Mountain Center. The point locations (1-3) are referred to in the text.

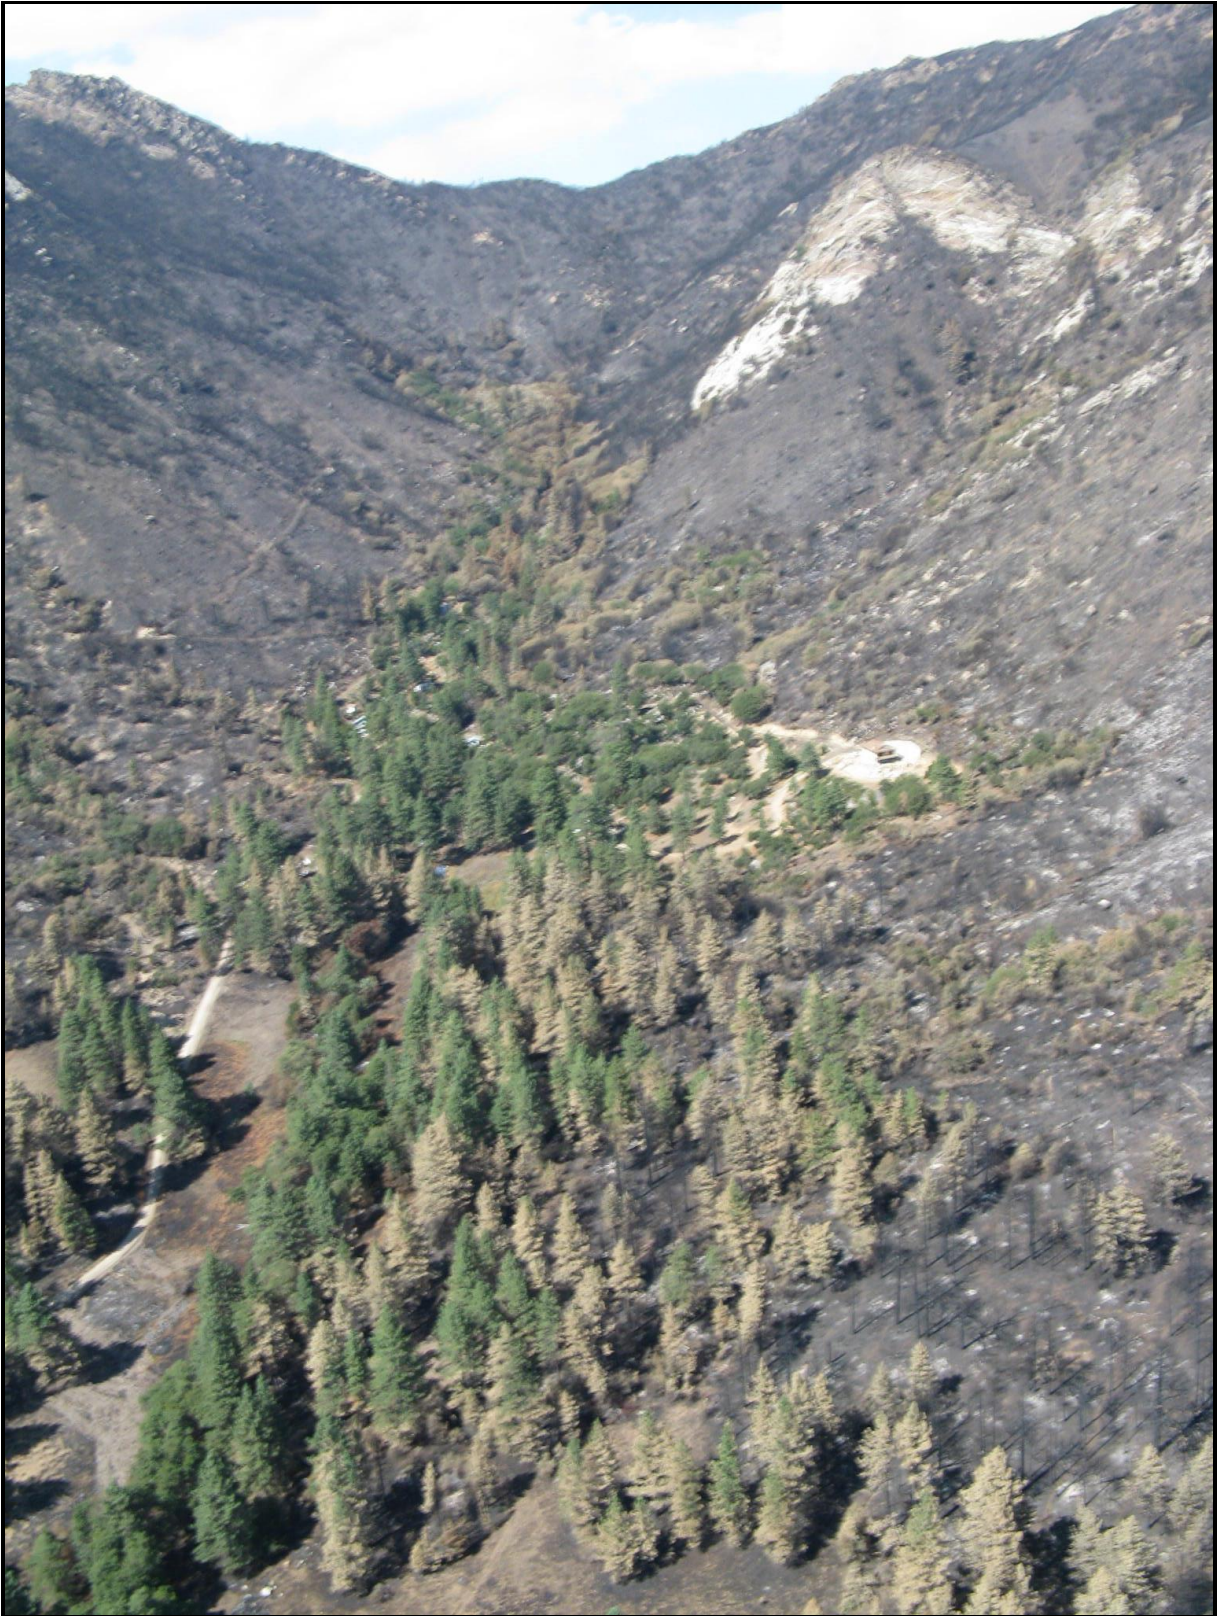
The Apple Canyon debris flow initiated in the headwaters of Apple Creek impacting the nearby Yokoji-Zen Mountain Center (hereafter referred to as “the Center”) (<http://zmc.org/?gclid=CPCF07ae0LgCFcaDQgoddQkAMQ>) (Figs. 1 and 2). During our initial field review on Friday, July 26, 2013, we found the personnel at the Center continuing cleanup using a small tractor and hand tools. We spoke with [REDACTED] who is the Roshi (Abbot) for the Center. He related how they had been clearing the debris for several days. They recognize the potential for a repeat of this event and have developed an evacuation plan for staff and visitors. It is their intent to alter the stream channel to an existing lower part of the floodplain and place structures (earthen?) to protect existing buildings. The cleanup made it difficult to assess the total volume deposited within the ground.

Figure 2. The Yokoji-Zen Mountain Center at the head of Apple Canyon. The Abbot's house is visible to the right (east) of the Center's buildings in the area of unburned trees.

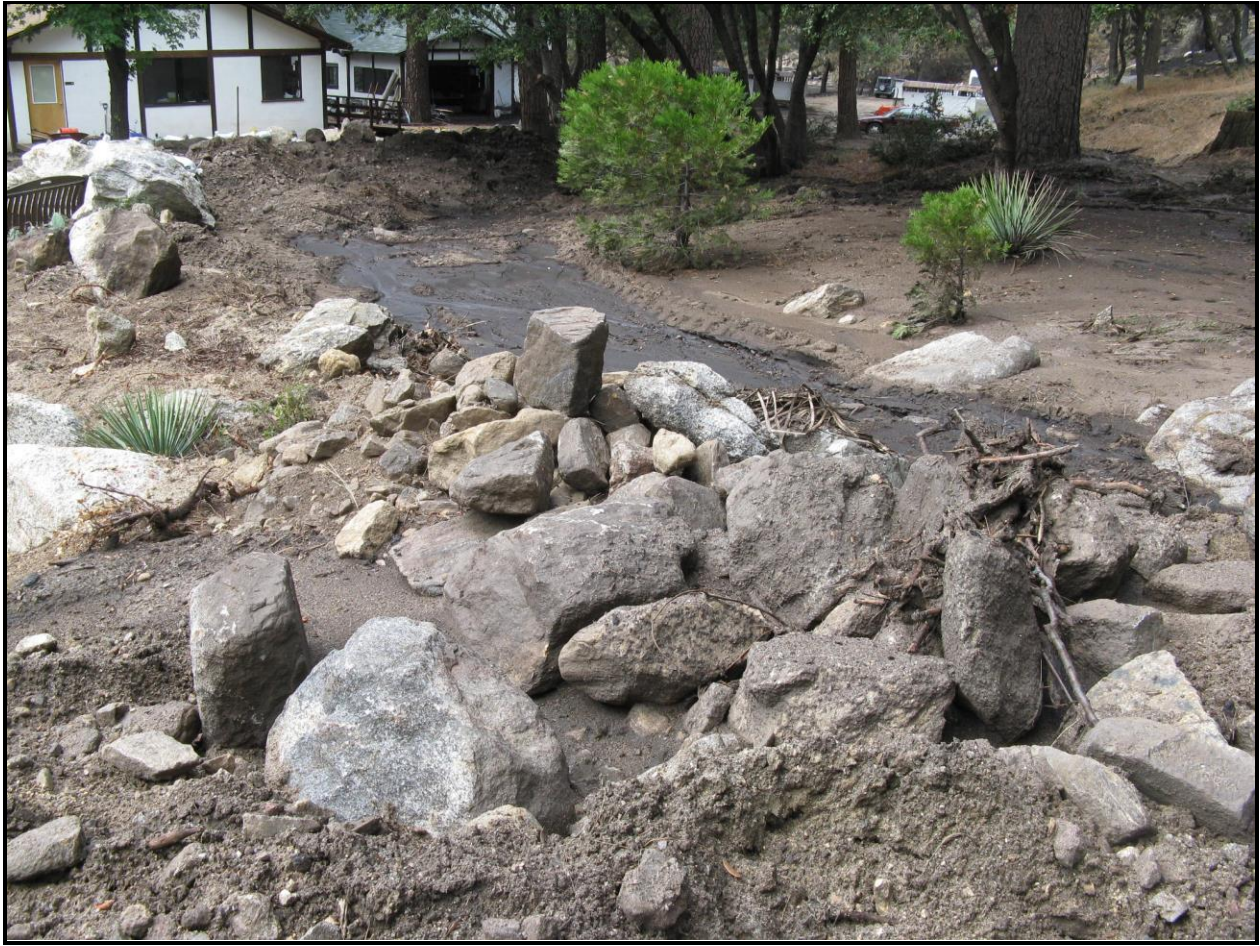
Mr. [REDACTED] stated that eighteen (18) inches of mud had filled the garage attached to one of the buildings next to the stream (Fig. 3). Some undisturbed deposit was present despite the extensive cleanup efforts (Fig. 4). Most of the onsite impact resulted from the large debris flow which entered the Center from the upstream part of Apple Creek. The material spread over the Center grounds on the existing valley fill. In addition to running out downstream from the Center, a part of the flow passed beyond the parking area onto the native-surfaced road. This material effectively blocked access down Apple Canyon road. Re-opening the road required excavation by Riverside County public works to enable cars to evacuate people from the Center.

Figure 3. Looking downstream along the channel of Apple Creek within the Yokoji-Zen Mountain Center in Apple Canyon. Apple Creek is visible in the small channel just past the boulder deposit. The white building in the left background is the administrative office. The garage (with open door) where deposition occurred is visible to the right and farther downstream relative to the office.

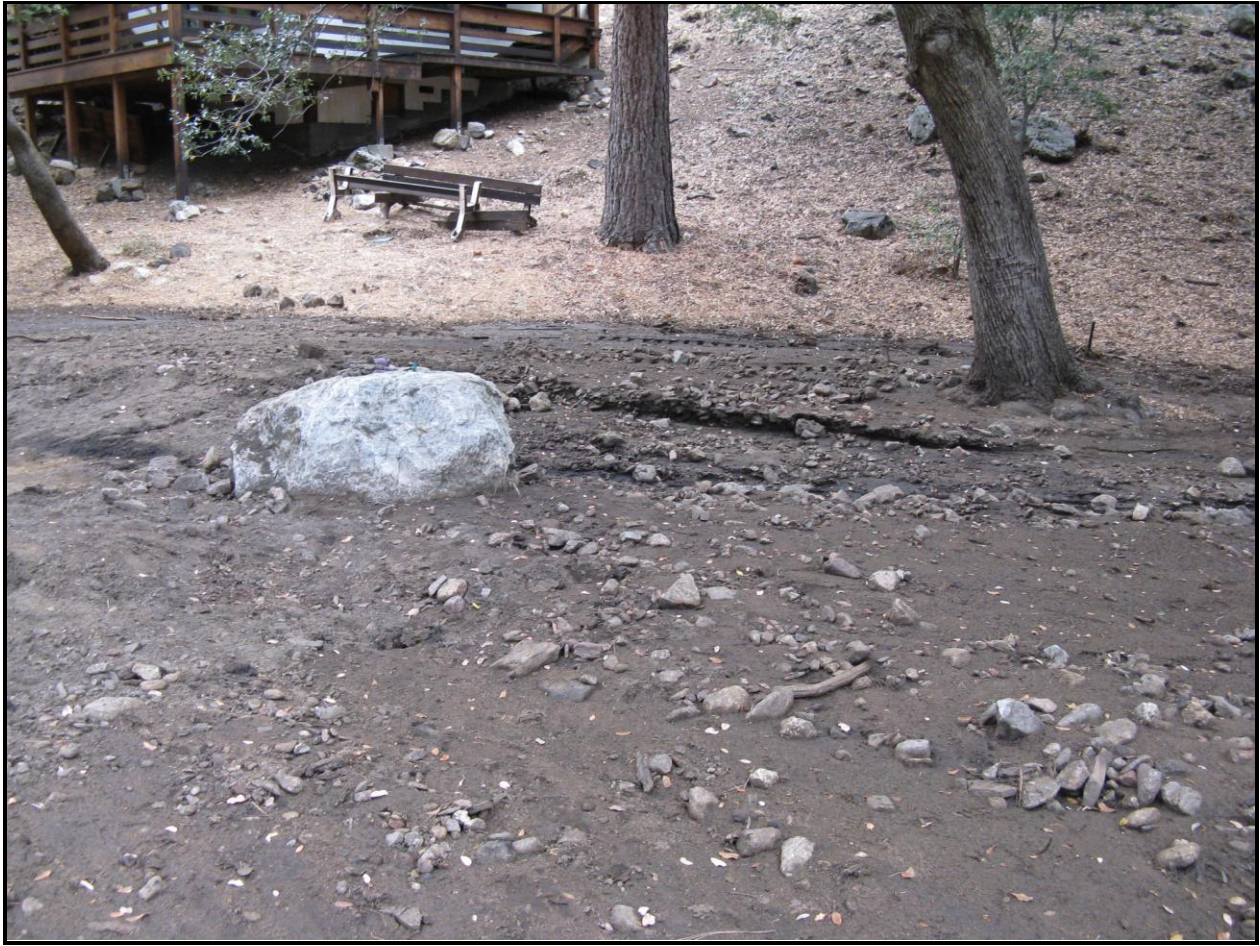
Figure 4. Within the Center grounds, the debris flows deposited across the surface of an alluvial fill. This shows material within an area of the Center grounds which is topographically lower than the present channel. This photo was taken at about 33.71828200/-116.63960800.

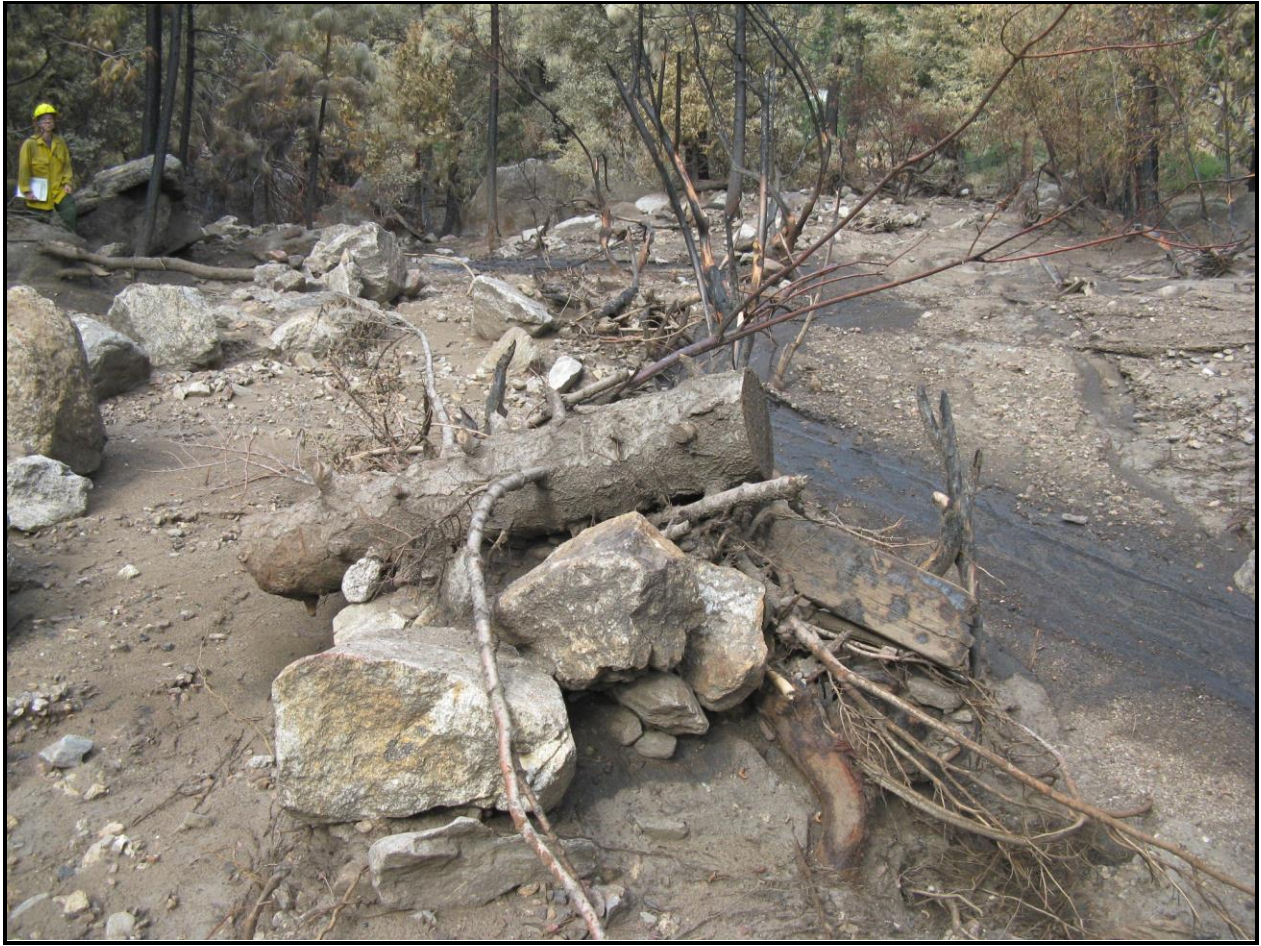
The debris flow in Apple Creek immediately upstream from the Center flowed over a 60-foot wide channel (Fig. 5). Several hundred feet upstream from the center, a tributary headed on the ridge to the east, contributed a debris flow to the one moving through the main channel. The tributary channel is scoured to bedrock through the lower few hundred feet (Fig. 6). The gradient is estimated to be ~60%. The survey continued up Apple Creek and observed discontinuous levees and other evidence of the debris flow’s passage (Fig. 7). The channel becomes more confined and narrows to

Figure 5. A view of the 60-foot wide impacted channel upstream from the Center. The debris flow passed from right to left. Part of a levee is visible in the foreground. A tributary debris flow entered behind and to the left of the individual taking this photo and contributed some of the material seen in the left foreground. The GPS coordinates for this location are: 33.71864800/-116.63870200.

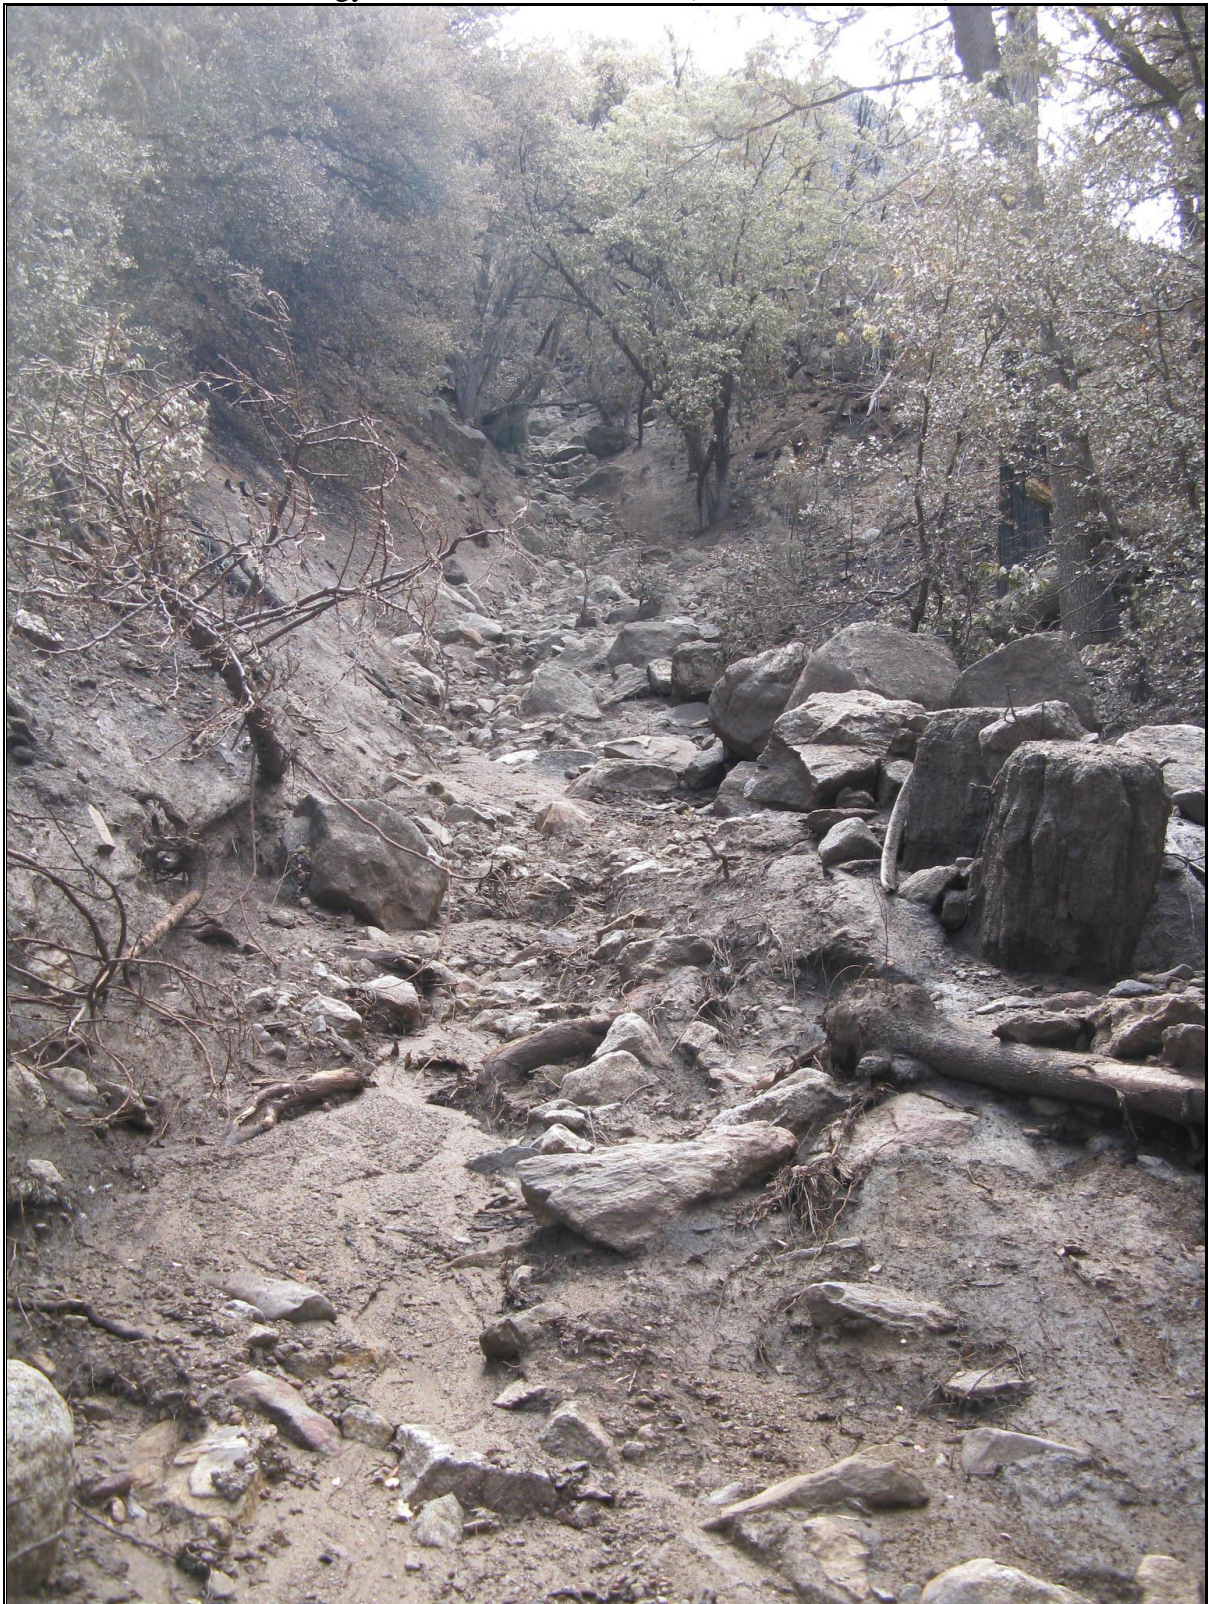
Figure 6. A view looking up the steep channel which was the source for the tributary debris flow entering the main channel at the location noted in Figure 6.

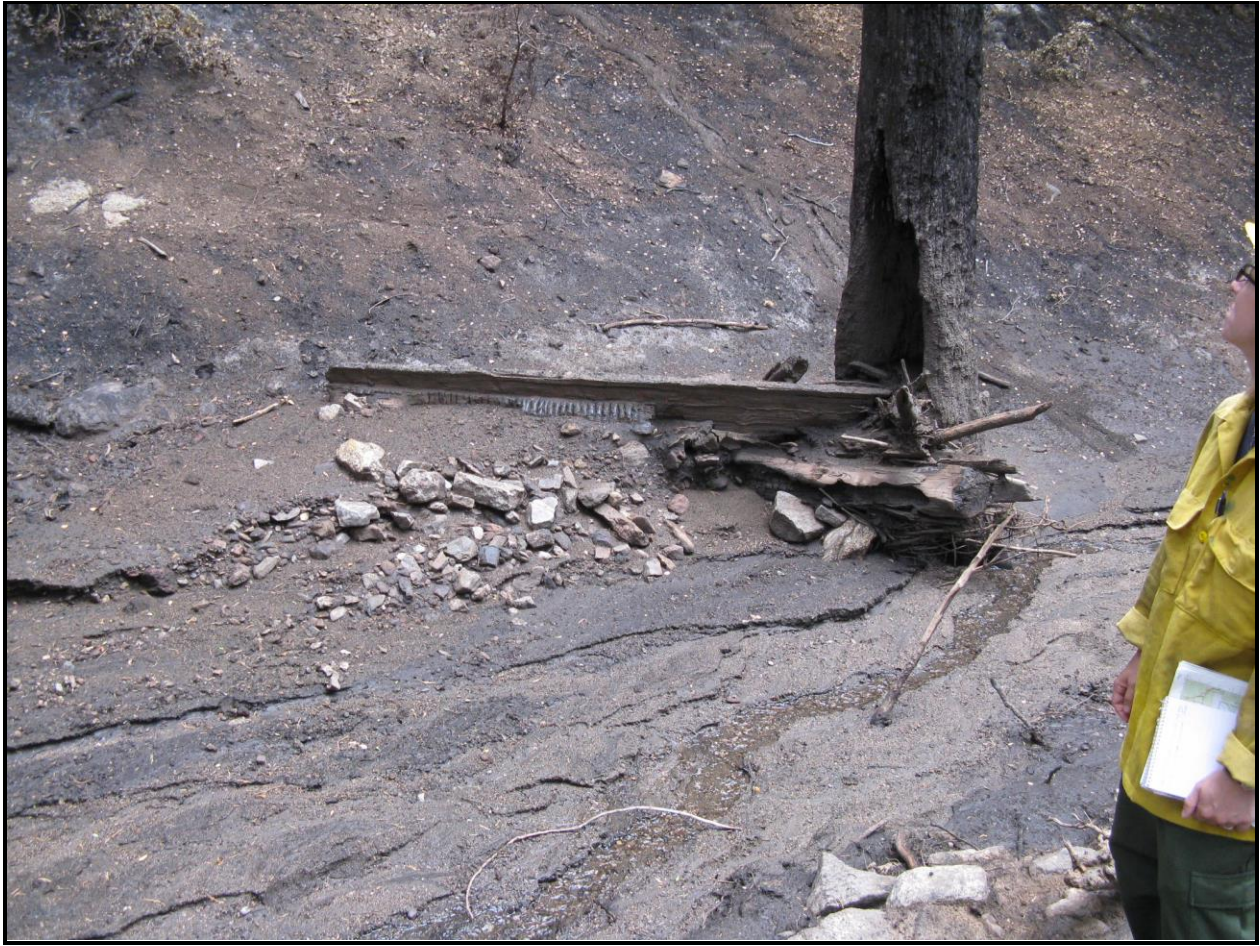
Figure 7. A view of the channel at the farthest point upstream from the Center where evidence of debris flow passage (discontinuous levees, matrix-supported large rock) was found. The GPS coordinates for this location are: 33.71959800/-116.63821000. Along the channel for several hundreds of feet upstream from this point only showed evidence of hyperconcentrated flow passage.

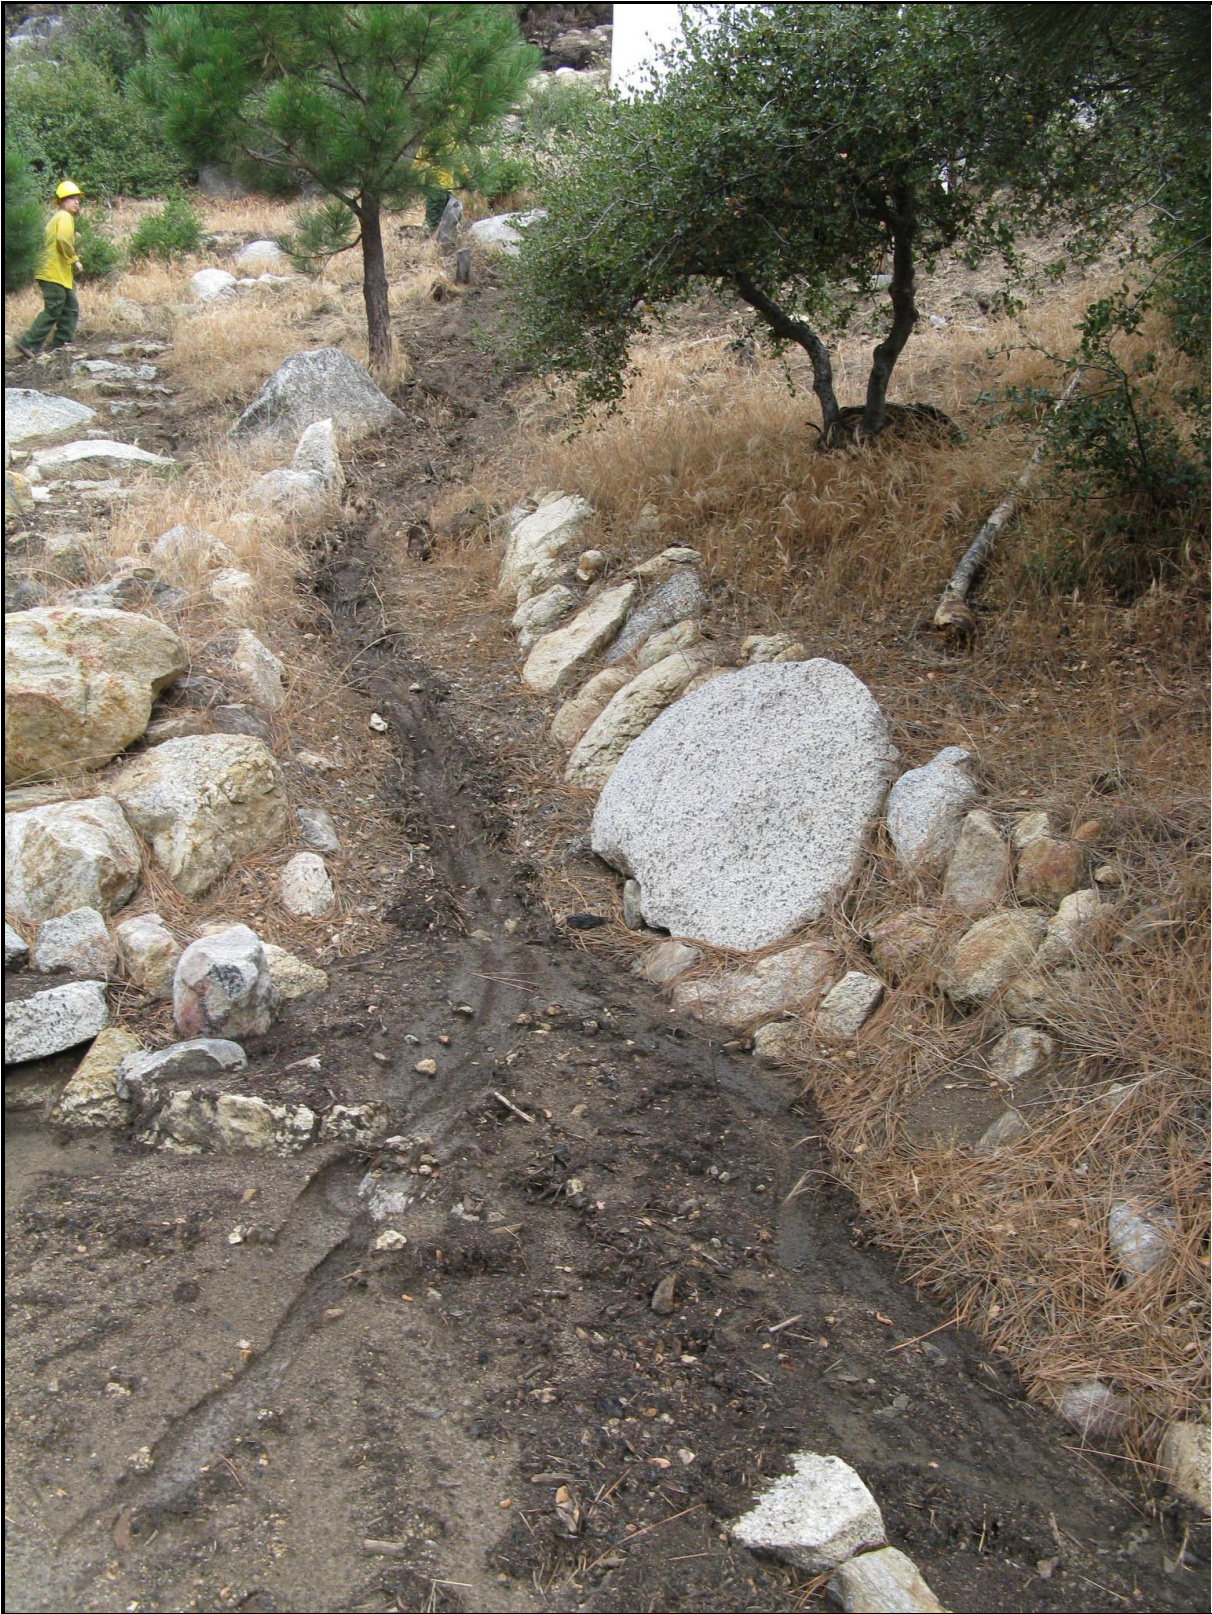
On the walk back down the channel to the Center, a small debris flow was seen entering the main channel from the west side (Fig. 8). The small debris flow was composed of finer-grained material with prominent levees. Following the debris flow upslope, it appeared to pass along a pre-existing footpath from a residential building. The debris flow had deposited on the step at the residence's doorway after having flowed down a steep slope below the access road to the Center's water wells. The debris flow had impacted and passed around another small structure just below the road before reaching the residence (Fig. 9). From the road, it was clear the debris flow originated from rilling on a steep burned slope upslope from the road. When the flow reached the road, it continued on the road surface for a short distance (few tens of feet) before passing onto the slope where the structures are located. Sandbags were placed along the outer edge of the road to block any future debris flow movement along this track to those structures. However, it will mean any future flow intersected by the road will continue down the road toward the Center's parking area. A helicopter overflight of the Mountain Fire took place on July 27, 2013. Photos show the extensive rilling visible on the slopes at the head of Apple Canyon (Fig. 10).

Figure 8. The lower part of the small debris flow near where it entered the main channel. This is looking upslope to the residence structure seen in Figure 8.

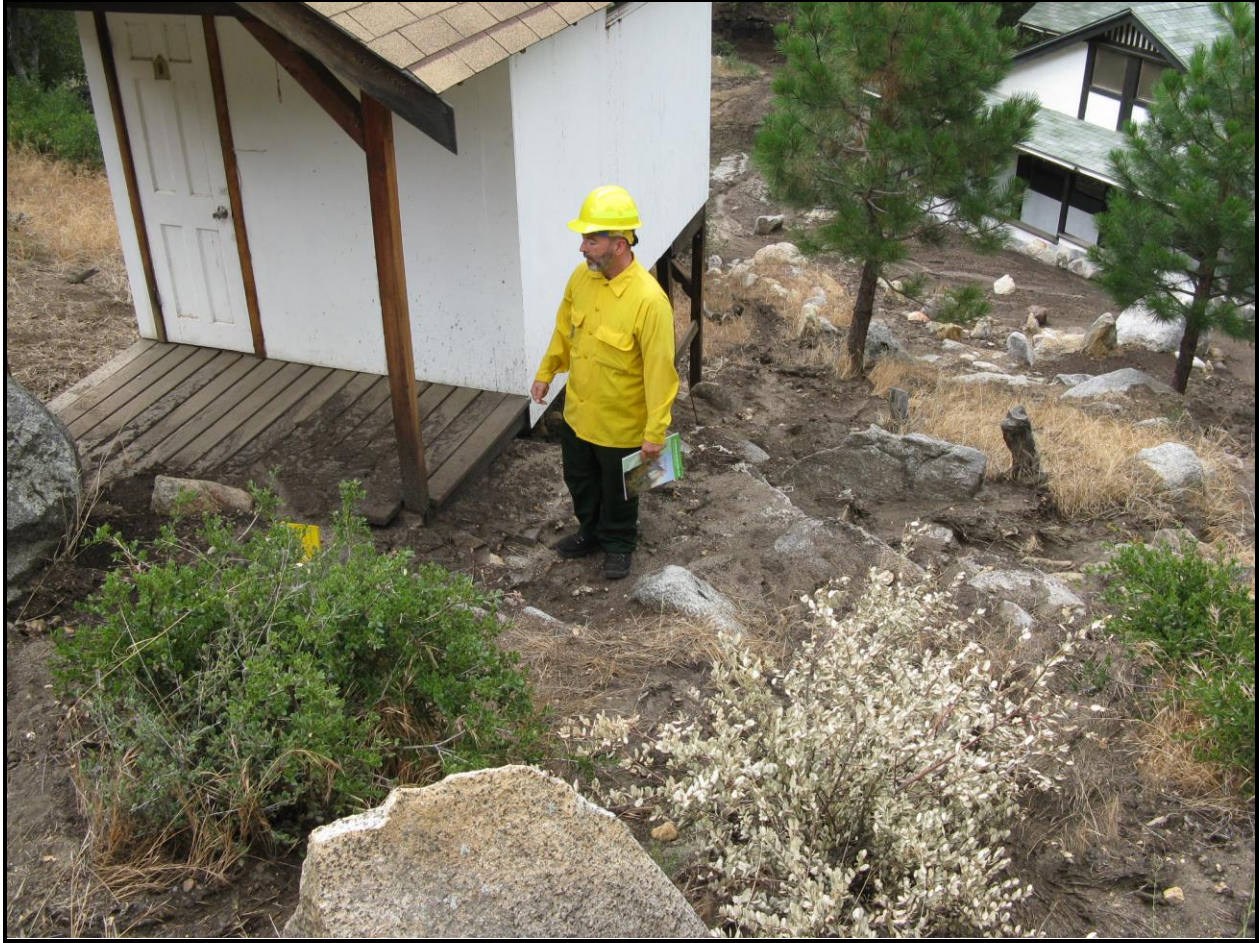
Figure 9. A small debris flow diverted by a minor access road passed downslope to impact this small structure and the porch of the residence below. This photo was taken from the edge of the road.

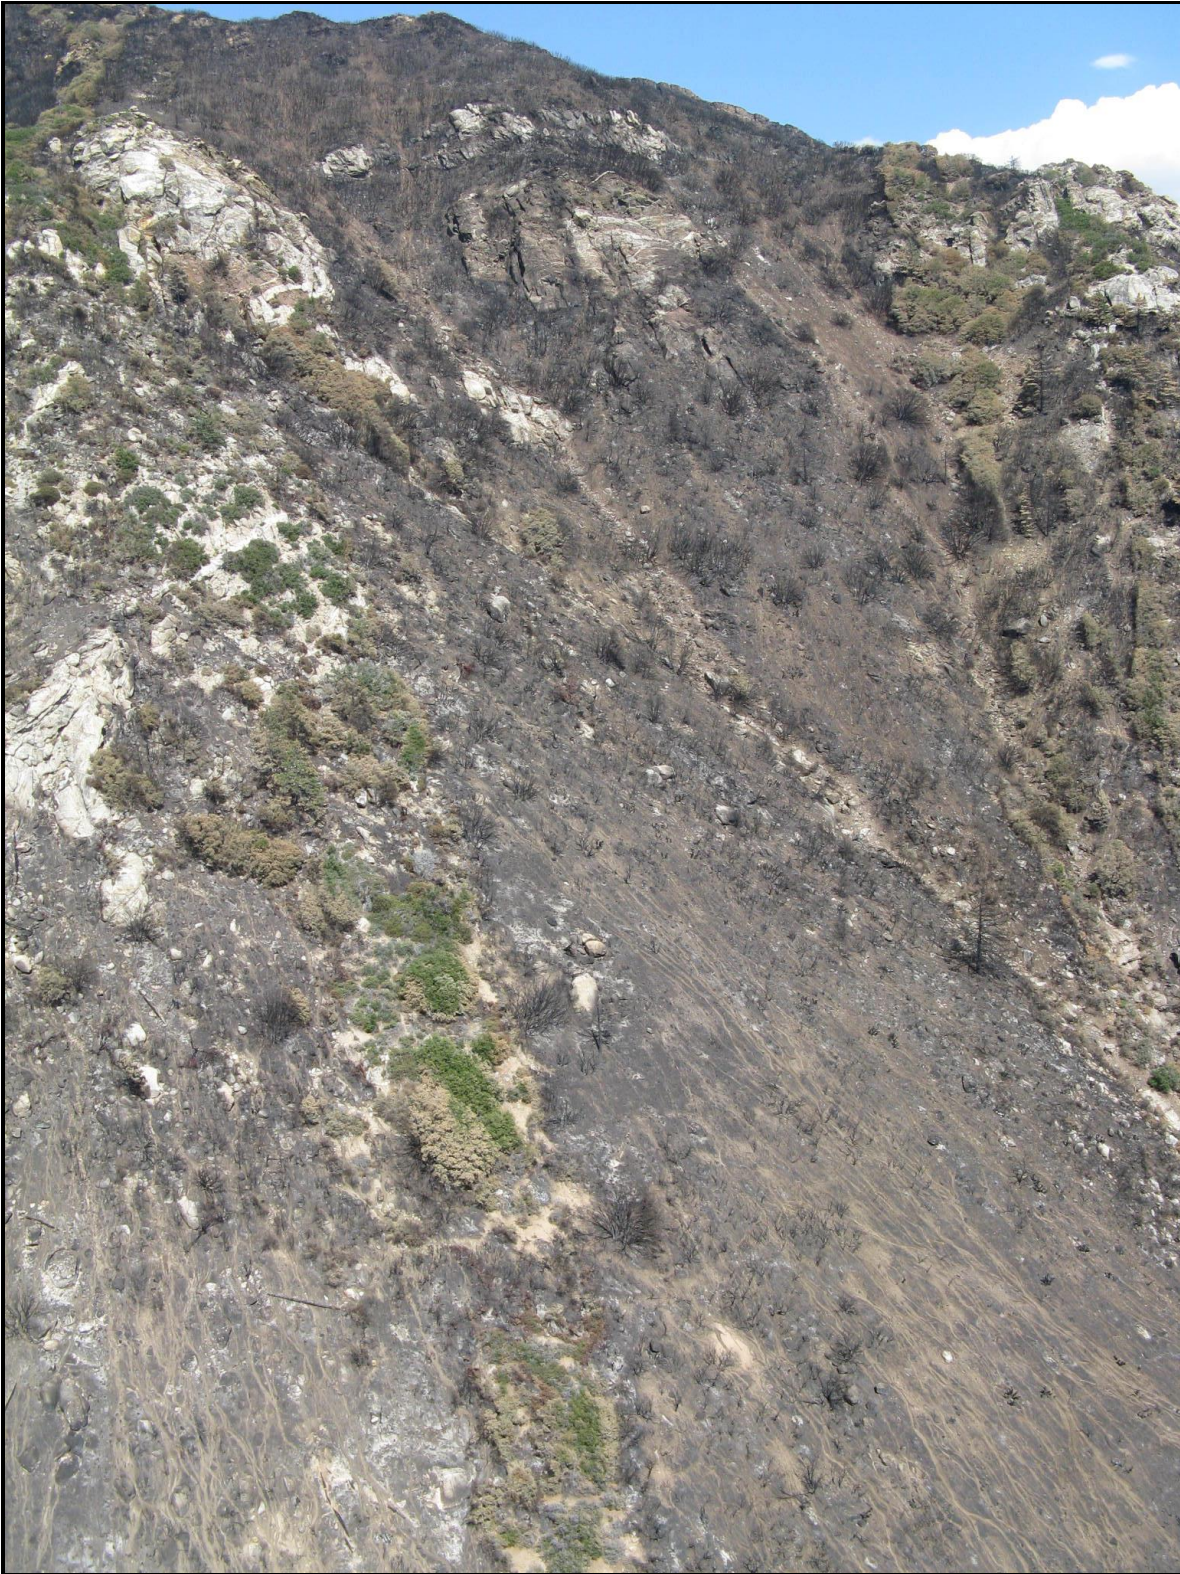
Figure 10. Some of the rilling visible on the slope above Apple Creek as seen from a helicopter overflight. This area drains into the upper part of the channel surveyed upstream from the Center. This is representative of rilling on steep slopes within the head of Apple Canyon.

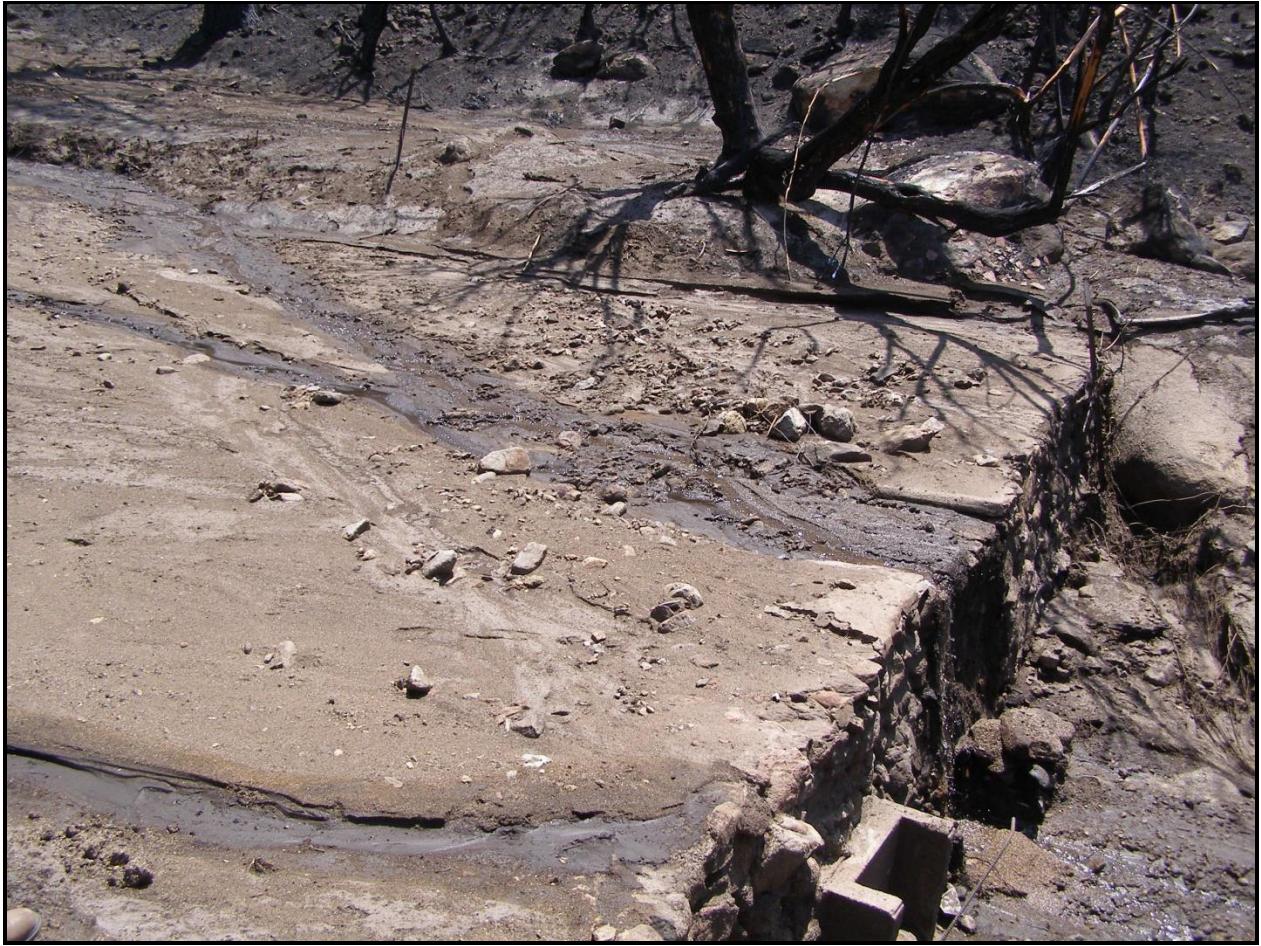
At the lower end of the private land parcel, which includes Spring Ranch and Bonita Vista Ranch, A major tributary to Apple Creek connects from the vicinity of Cartridge Spring and the adjacent slopes between Apache and Spittler peaks. The area along the upper part of this tributary burned at high and moderate burn severity not unlike the conditions above the Yokoji-Zen Mountain Center. A water impoundment is located just before the tributary joins the main channel. Like at Spring Ranch, this pond was completely filled with sediment to the full height of the small dam (Fig. 11). Evidence along the channel upstream from the pond as far as the Cartridge Springs area, the material deposited in the pond was due to flooding. Debris flow levees and similar features were absent (Fig. 12). It is possible the event was actually a hyperconcentrated flow.

Figure 11. The sediment-filled impoundment on the tributary to Apple Creek resulting from the July 21, 2013 storm event.

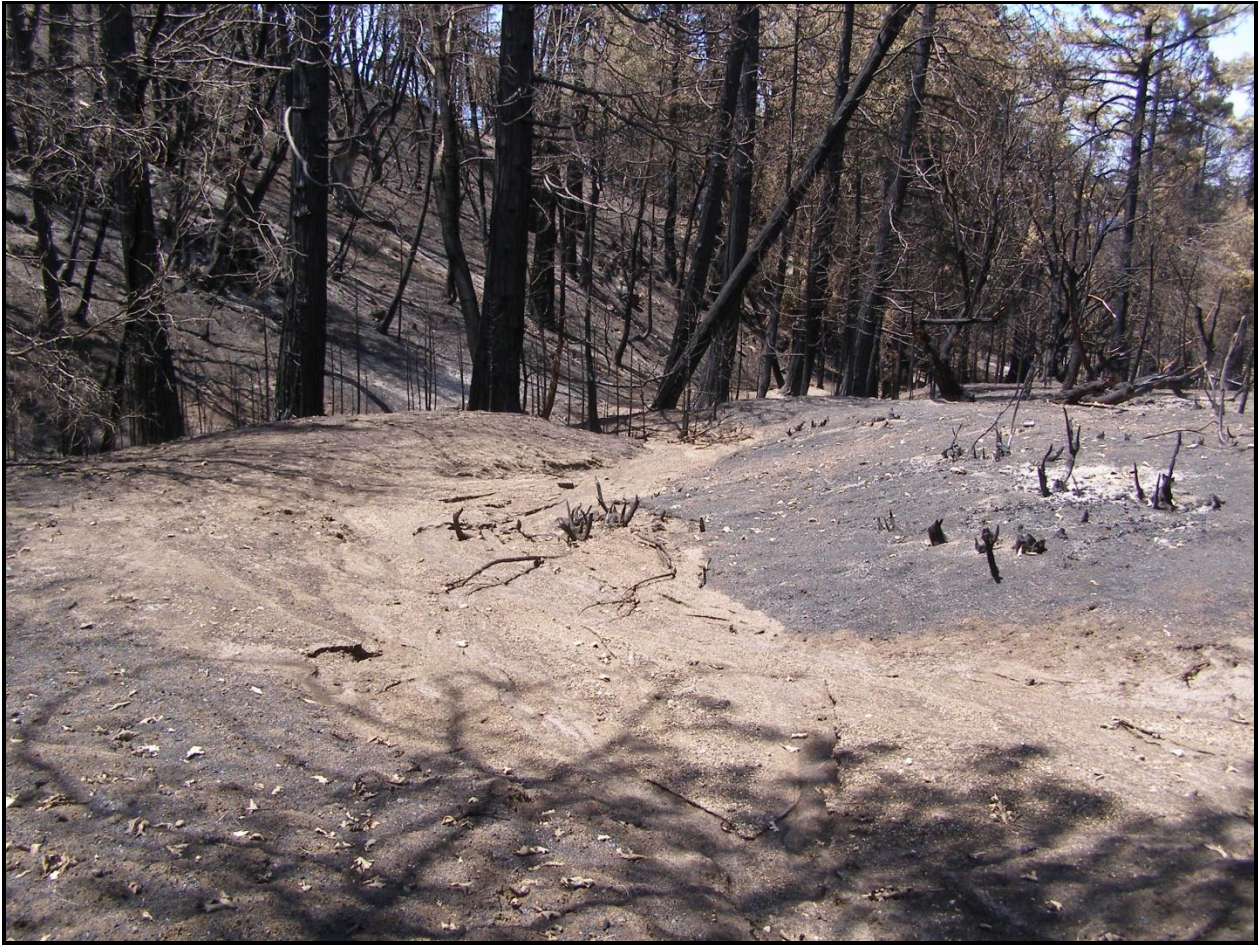
Figure 12. Deposition along the tributary to Apple Creek from the passage of the sediment-laden water.

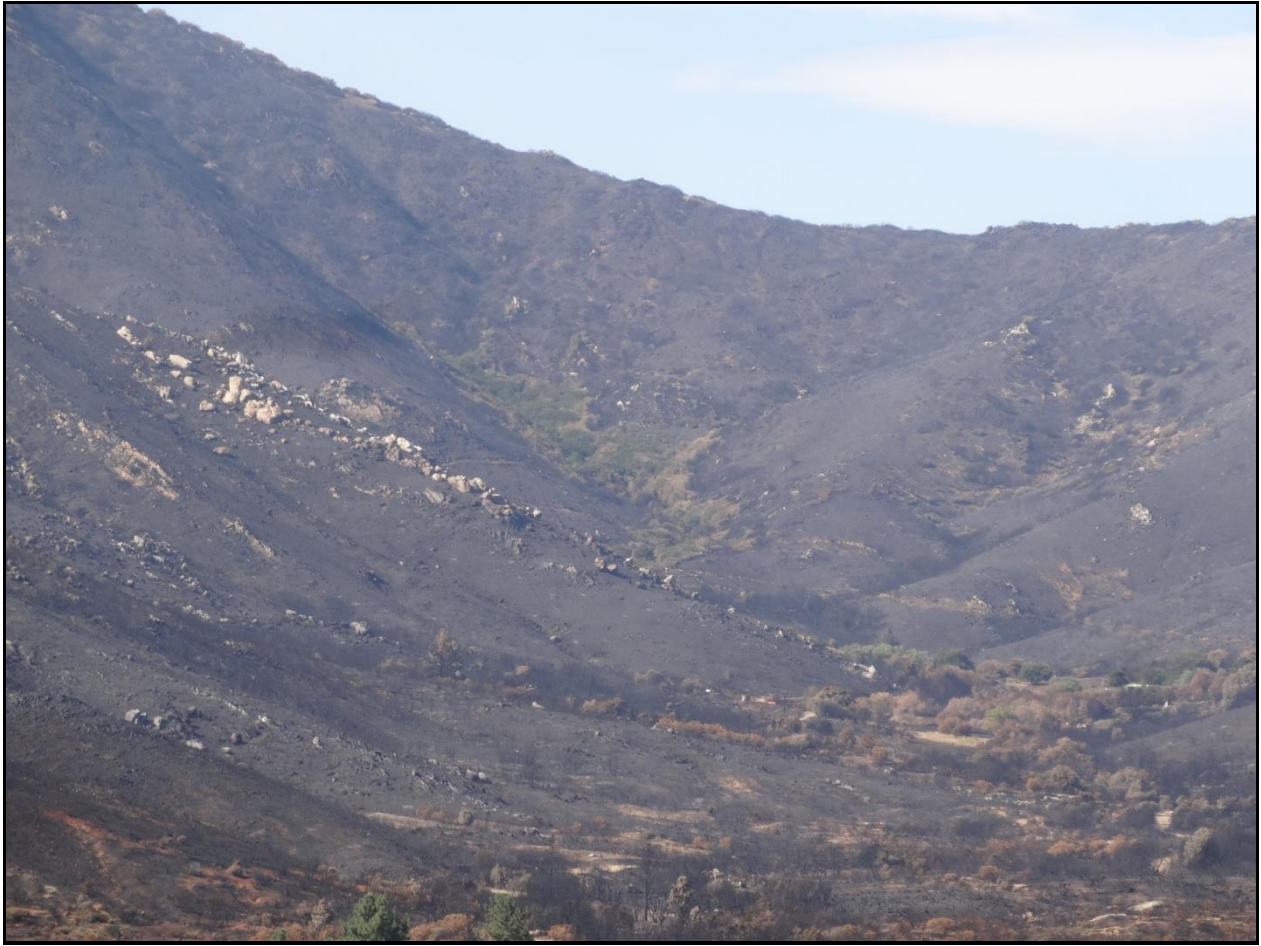
A watershed response to the storm was observed for Fobes Ranch in Fobes Canyon. While the flooding impacted some parts of Fobes Ranch near the head of the canyon and the road downstream, it was clearly water with a high concentration of sediment and ash. Limited damage was caused by this flooding. Figure 13 shows the location of the ranch within the head of the canyon. Evidence of a sustained muddy water flow within the channel was seen as far downstream at the fire perimeter. At one point within one-quarter mile of the ranch buildings, deposits on the road from nearby rilled slopes were observed to join with the main channel. Only evidence of muddy water was seen during a survey within the ranch (Fig. 14). The owners indicate that water flooding is commonly experienced within the ranch grounds during seasonal storms. No damage was sustained by the ranch structures and facilities clustered in the flat during this most recent storm event. Only muddy sediment was seen along the drainages through the ranch area. The

Figure 13. Fobes Ranch (scorched trees and buildings in right foreground) near the head of Fobes Canyon. A large patch of unburned (green) is associated with a major spring.
